WINDY CITY
HOME INSPECTION INC.

HOME INSPECTION REPORT

1234 Pleasant Valley Dr. #109, Suburbia IL 60111

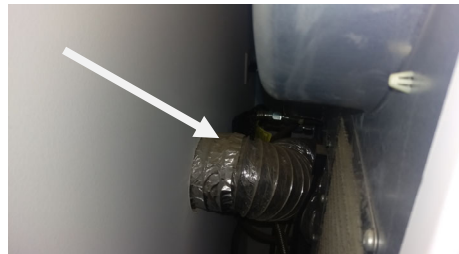
Foil exhaust line at dryer

Foil exhaust line at dryer, recommend replacing with flexible metal or metal tubing. (Photo)
 Recommend maintaining an unclogged/sealed/damage free exhaust line at dryer.

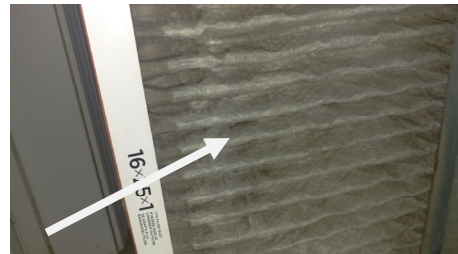
Furnace filter in need of replacing

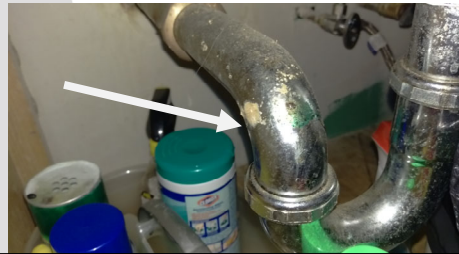
Corroding metal drain pipes

Microwave surface lights did not function when tested, recommend further evaluation/repair.
 Corroding metal drain pipes present, replace as necessary. (Photo)

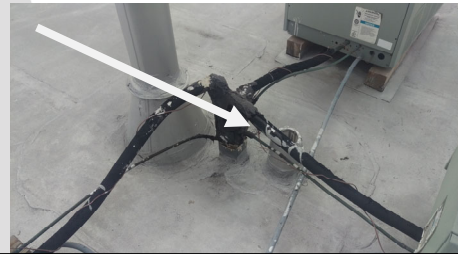
Damaged/missing insulation at A/C lines

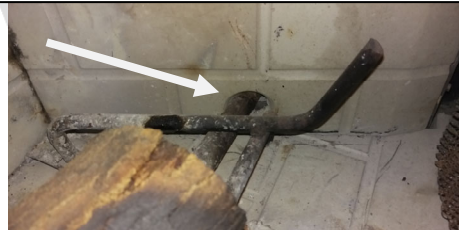
Gaps where gas line enters fireplace

- Foil exhaust line at dryer, recommend replacing with flexible metal or metal tubing. (Photo)
- GFCI outlet at rear balcony is not tripping, recommend repairing/replacing.
- Gaps where gas line enters fireplace, recommend sealing with fire rated grout. (Photo)

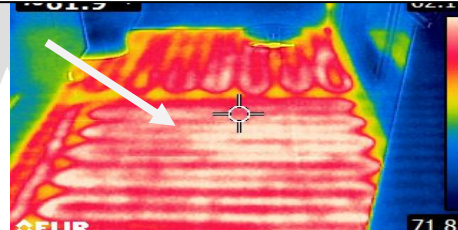
Radiant floor is functioning
